Union Mills :

**A Study for the Improvement,
Restoration, and Protection of
Mill Pond...**

**Save Our Pond Committee
Union Mills, IN 46382**

February 1990

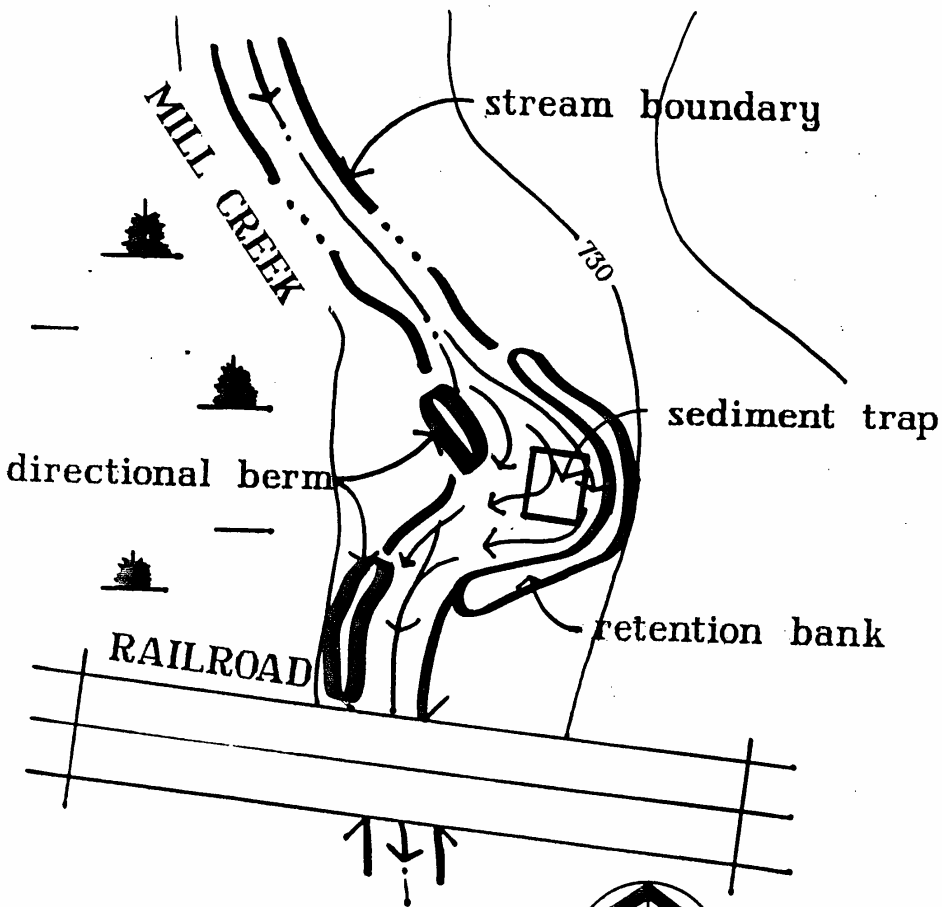
Figure 35

UNION MILLS
WETLAND CONCEPT
detail a

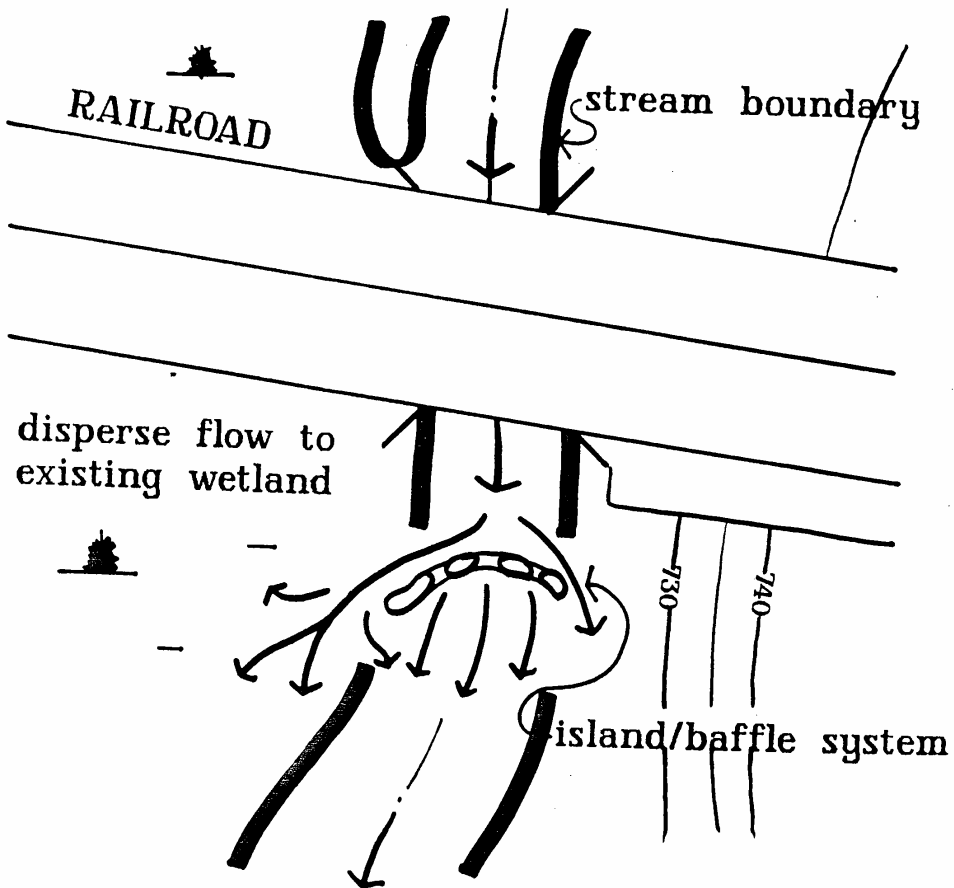
Figure 36

UNION MILLS WETLAND CONCEPT detail b

3. Detail 'b', 'c', and 'd'. This project is intended to divert flow from the channel to the wetland at the upper end. The project would provide semi-long term utilization of the wetland, however the wetland would rechannelize in time.

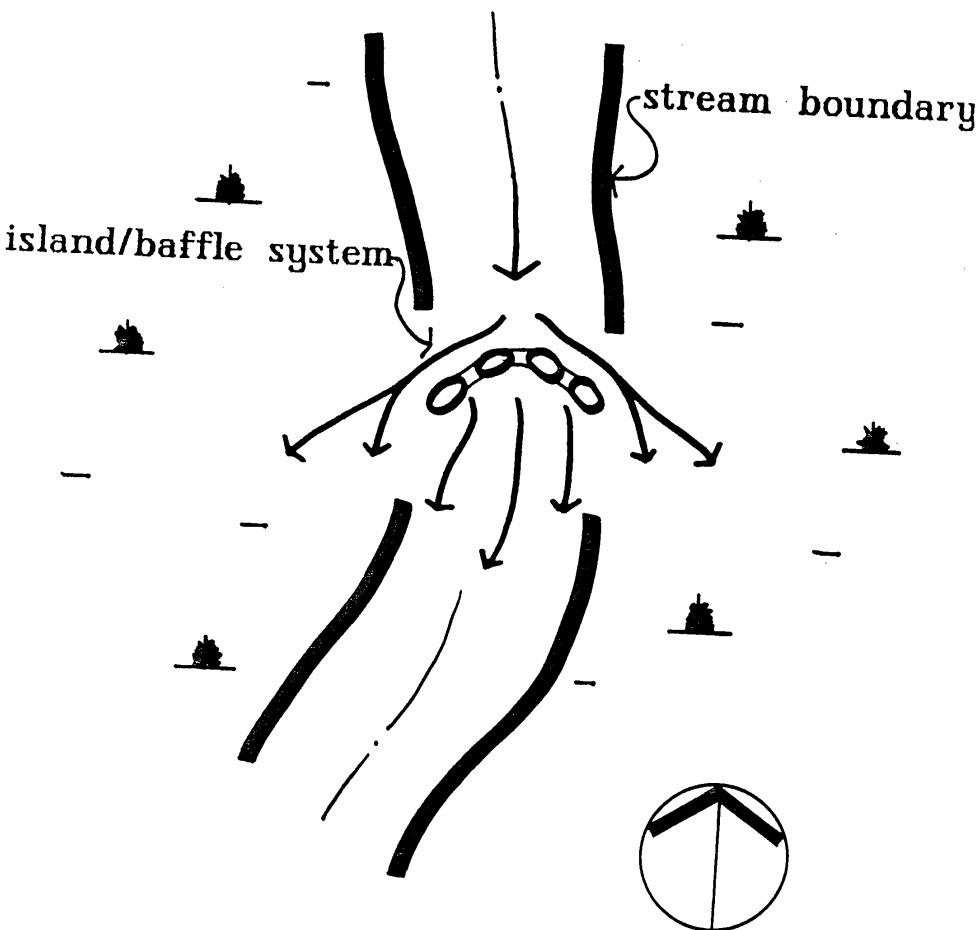
Figure 37

UNION MILLS
WETLAND CONCEPT
detail c
